KENDA DAM
WESTMORELAND COUNTY, COMMONWEALTH OF PENNSYLVANIA
(NDI No. PA 00459,
PennDER No. 65-118), Old River Bridge
Number

PHASE I INSPECTION REPORT
NATIONAL DAM SAFETY PROGRAM

PHASE I REPORT
NATIONAL DAM INSPECTION PROGRAM

Kenda Dam, Westmoreland County, Pennsylvania
NDI No. PA 00459, PennDER No. 65-118
Tributary of Little Sewickley Creek
Inspected 14 December 1979

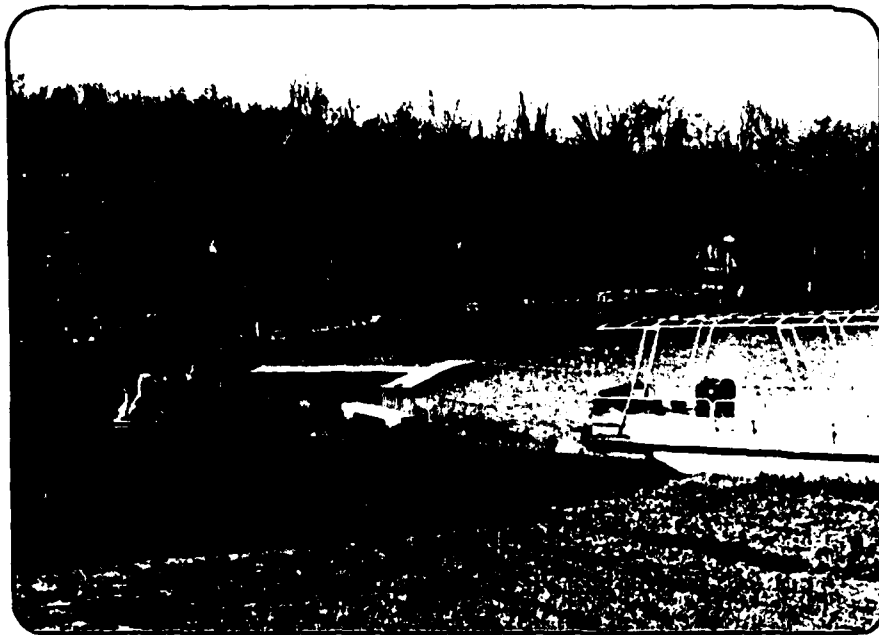
View of Upstream Side of Dam from the Left Abutment

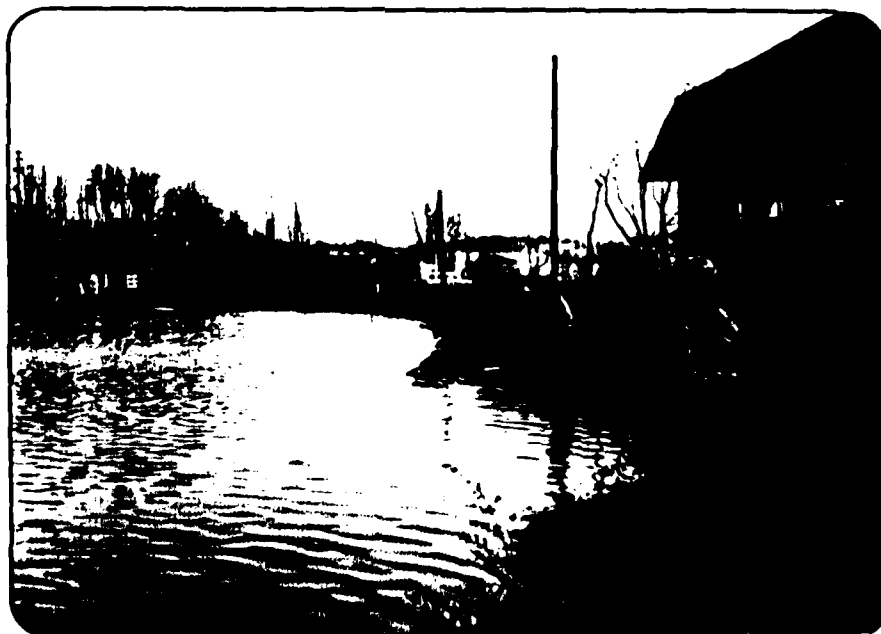
View of Upstream Side of Dam from the Right Abutment
